Manhole Inspection Summary

Manhole # S3700_006MH

Location Address: **2200 ALLEY_23RD 22ND**

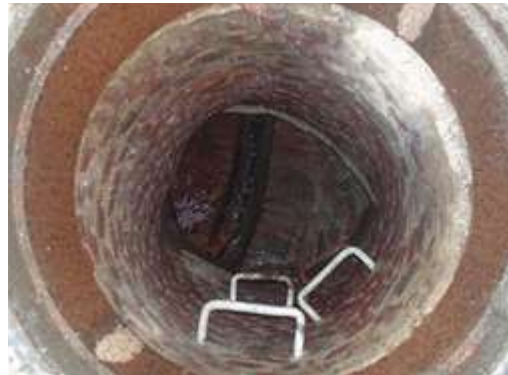
Top View

Corroded steps. Bench debris.

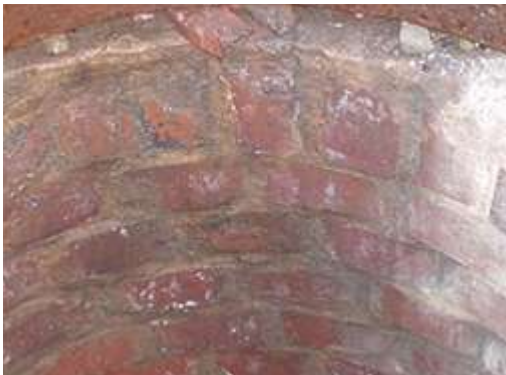
Defect

Frame leaks. Adjustment deterioration, loose brick and infiltration.

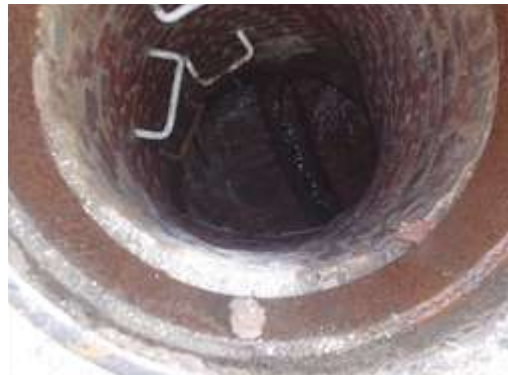
Defect

Frame leaks. Frame offset. Adjustment deterioration, loose brick and infiltration. Barrel infiltration.

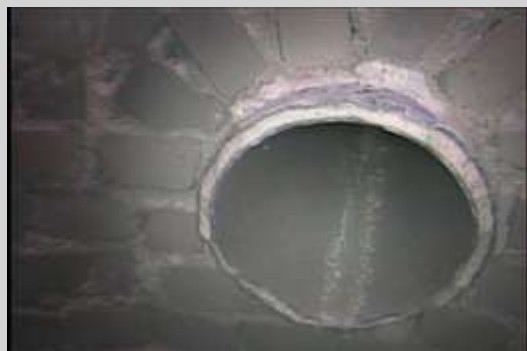
Pipe In @ 9 O'Clock

Pipe Seal Cond: **Broken**

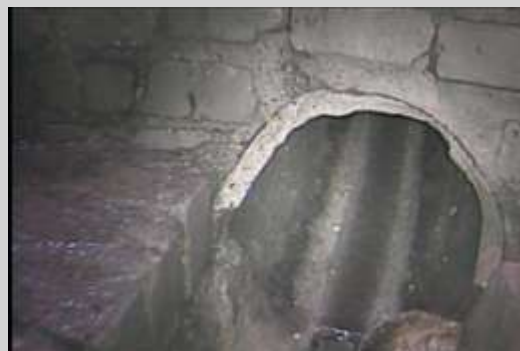
Drop In @ 9 O'Clock

Drop Condition: **Open**
